News Waves

EDITION # 2014/01

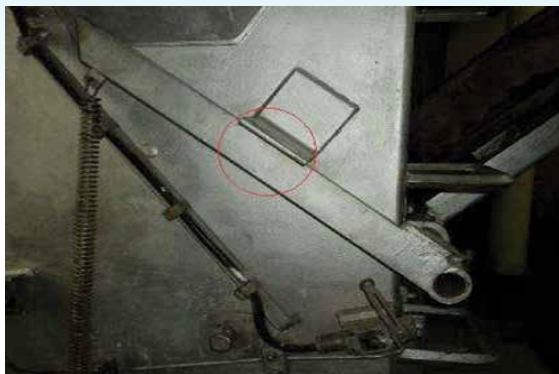
▲ Incinerator with door closed

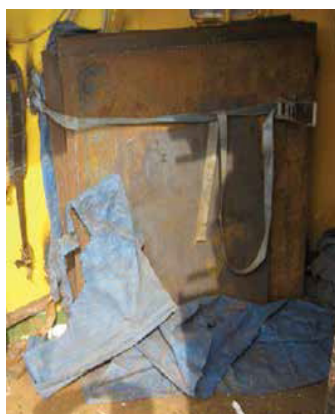
Two deckhands were detailed to replace the torn tarpaulin covering some steel plates, which were stored upright on the poop deck. The 20 plates measured approximately 1.4m x 1.2m with a thickness of 5-10mm, and weighed about 1000kg in all. In order to undertake this task the deckhands released the single lashing strap that held the plates in place so as to free the tarpaulin. Upon release of the lashing strap several plates began to topple over, falling on top of one of the attending deckhands.

Improper vertical storage and securing of steel plates, especially with only one securing strap and no wooden or other deck underlays to increase friction, unnecessarily increased risk.

Editor's note: The BSU report also noted a similar accident just a few months earlier where the crewman was fatally injured due to falling plates that were vertically stored. Beyond the specific findings of this report it is important to realise the insidious nature of certain seemingly innocuous conditions. How dangerous can a few plates be? We tend to view such conditions as 'normal' — but there are hidden risks if only we had stopped and thought about it for a minute. Such hazards probably exist on your vessel. Go around once again with new eyes and renewed interest to try and spot the risks before any negative consequences occur. Readers are encouraged to report back to the MARS editor with descriptions and photos of what they find and any corrective action taken.
